**Minutes of the meeting held on 20.05.2023 by the Managing Director in the chamber of Chief Engineer (CR), Kochi regarding the co-treatment of septage at Elamkulam STP, Kochi**

**ബഹു. ദേശീയ ഹരിത ട്രൈബ്യൂണലിന്റെ OA 673/2018 ഉത്തരവ് അനുസരിച്ച് പെരിയാർ നദിയുടെ ഗുണനിലവാരം മെച്ചപ്പെടുത്തുന്നതിനായി തയ്യാറാക്കിയ കർമ്മപദ്ധതി നടപ്പിലാക്കുന്ന തുമായി ബന്ധപ്പെട്ട് 26.05.2023 - ൽ District Level Technical Committee (DLTC) അംഗങ്ങളുമായി വീഡിയോ കോൺഫറൻസ് മുഖാന്തരം നടത്തിയ യോഗത്തിന്റെ മിനിറ്റ്സ്**

The Hon'ble NGT on 22/03/2022 in OA 147/2022 observed high Biochemical Oxygen Demand (BOD) levels in Ashtamudi at Thoppilkadavu and KSRTC. As a result, the NGT directed the identification of pollution sources and implementation of remedial measures.

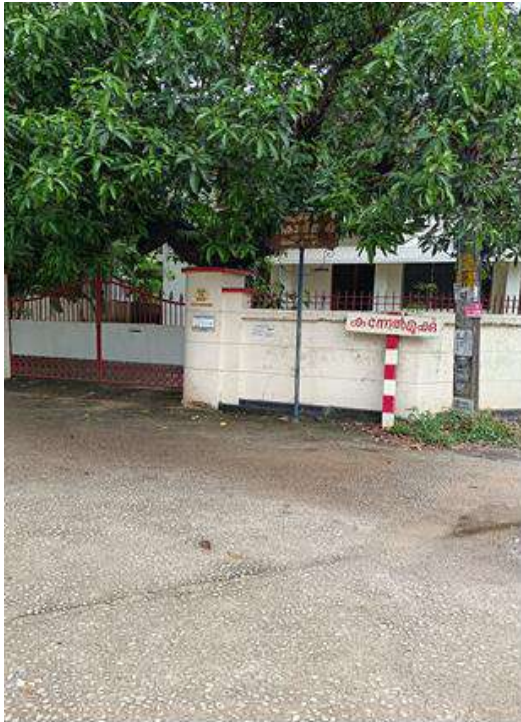
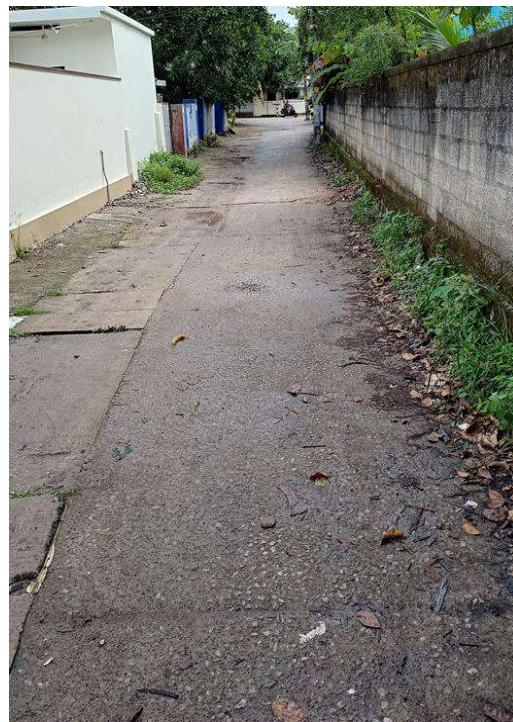
Fig 1.1: Location 1: Manichithodu near Kunnelmukk (Vikas Nagar)

Based on the field visit, it was observed that the Manichithodau originates from Palayathodu. At the Kunnelmukk section of Vikas Nagar, several small rainwater drains from Jawahar Nagar and National Nagar converge, forming the Manichithodau. In this area, the drain is covered with slabs. Moving from Kunnelmukk, the watercourse crosses the Palayathodu -Manichithodu road and continues its course along the right side.

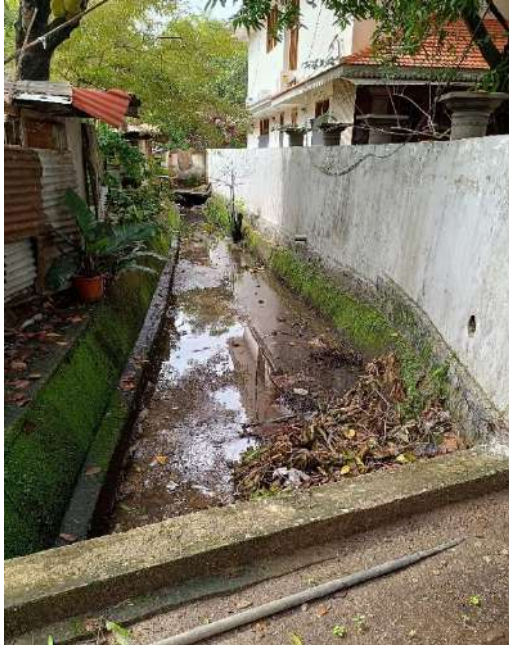
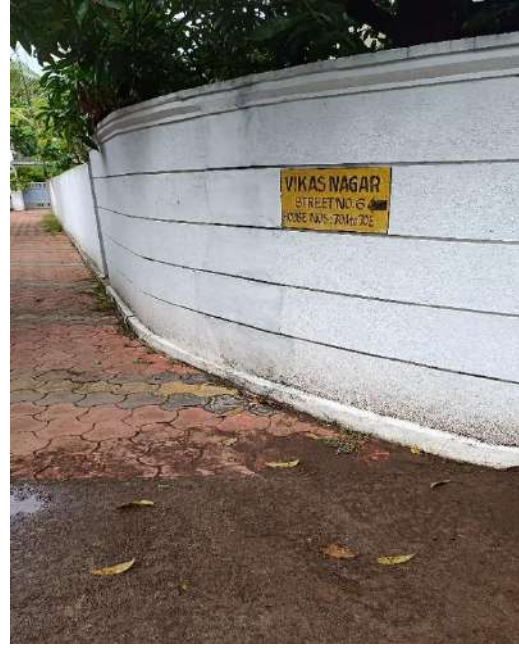
Fig 1.2: Location 2: Vikas Nagar – Street No.6

During the field visit near Street No. 6 in Vikas Nagar, it was observed that the stream flows between houses, a short distance away from the road. Notably, in this specific area, the ditch lacks slab coverage, leading to a significant accumulation of garbage. The issue of waste dumping in this location has been acknowledged by the local residents.

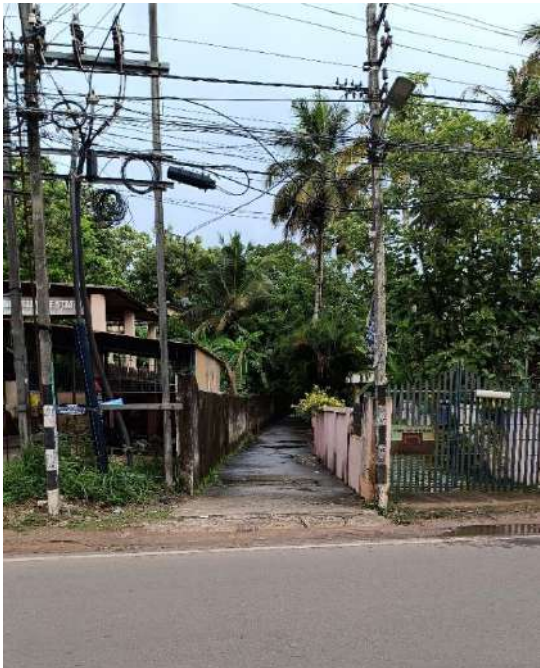
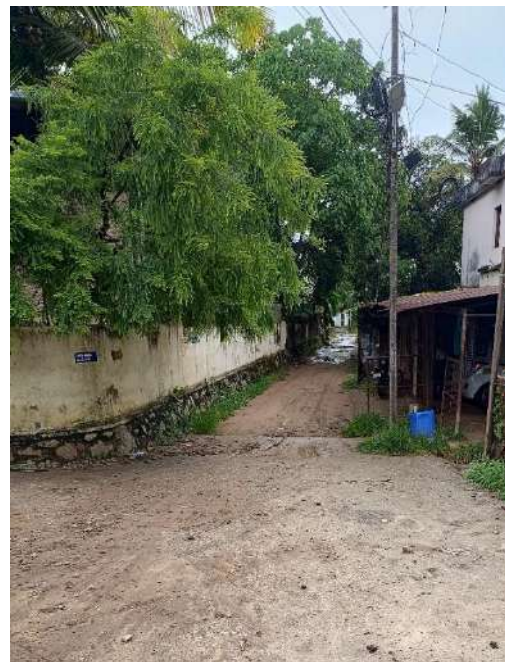
Fig 1.3: Location 3: Divya Nagar, Manichithodu, Pattathanam

Manichithodu stream passes in close proximity to Vimala Hridaya School, slightly away from the road, and runs parallel to it until it reaches Manichithodu Junction. These sections of the stream have been entirely covered with slabs, effectively serving as roads. At Manichithodu Junction, Drainage crosses the Chemmanmukk-Ayathill road, and from there, it continues towards the railway line through Divya Nagar on the Pattathanam side.

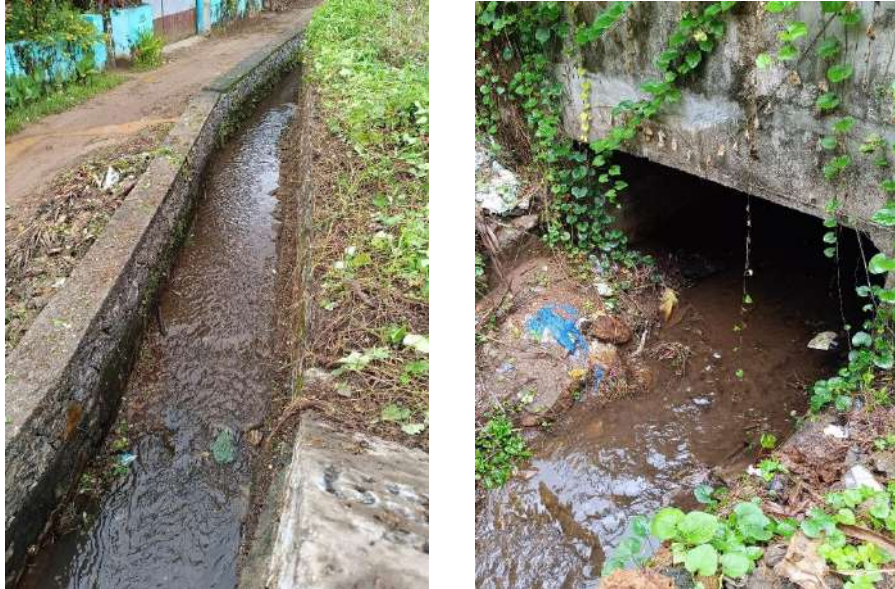
Fig 1.4: Location 4 & 5: Railway Culvert near Pattathanam and NTV Nagar

It should be noted that a small portion of the ditch near the railway line remains uncovered. Despite ongoing cleaning efforts in this area, residents report frequent instances of sewage and garbage entering the stream from upstream during rainfall, as well as improper disposal of waste in the nearby vicinity.

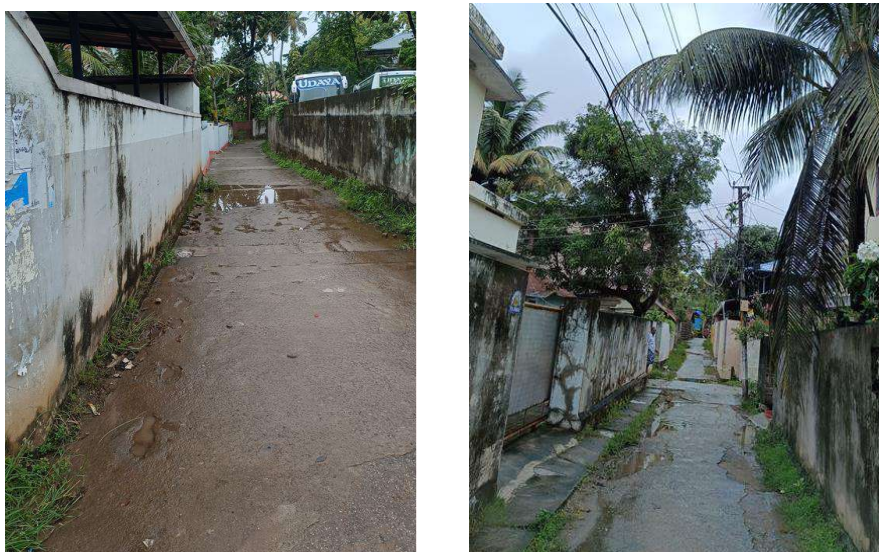
Fig 1.5: Location 8: Manichithodu - Completely covered with slabs in Peoples Nagar

Subsequently, the stream that passes through the residential area of NTV Nagar has been completely covered with slabs. Consequently, it becomes challenging to assess the current condition of the canal in these particular sections.

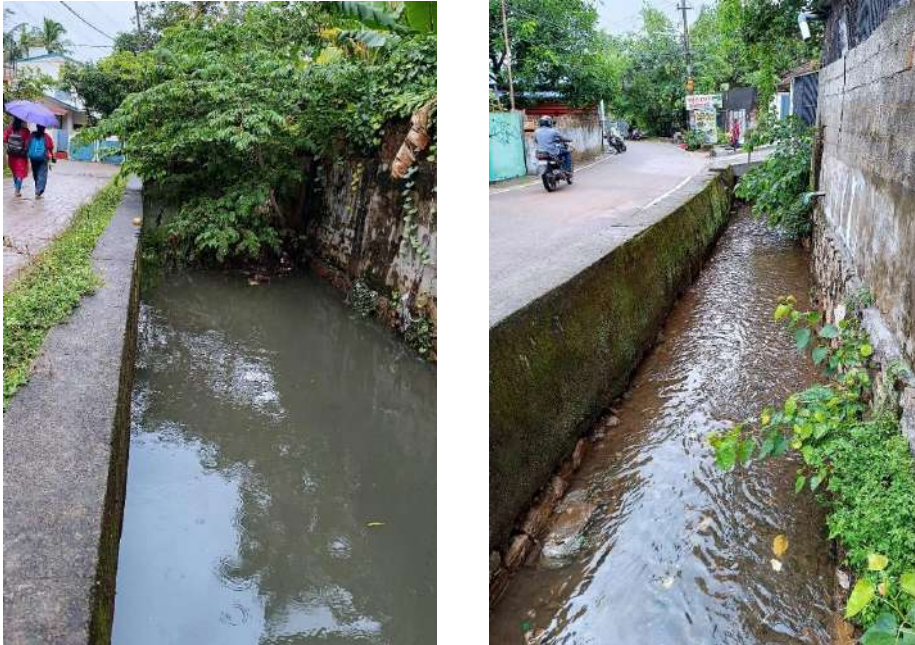
Fig 1.6: Location 10: Manichithodu - Areas of Harishri Nagar and Aradana Nagar

Near St. Thomas Church, the stream continues and reaches the People's Nagar side as it passes under the bridge located on Kapalandimuk-Kadapakkada road. There are many houses and commercial establishments on both sides of the stream that flows through People's Nagar. In this densely populated area, the ditch is slabbed and used for the convenience of transportation. The stream flowing behind the District Fire and Rescue Office crosses the main road Kollam-Kotarakkara road.

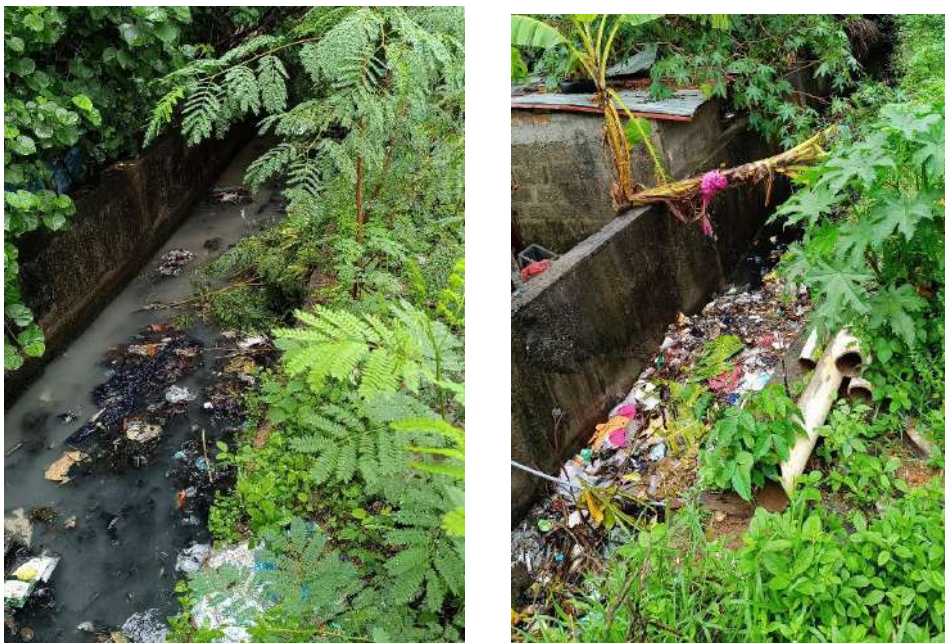
Fig 1.7: Location 12: Manichithodu – behind Pullikada Colony

The area between Kuravan Bridge and the Mouth of Manichithod is severely affected by the accumulation of garbage. Various types of waste originating from upstream sources are brought down

by the stream and accumulate in this section. The presence of this extensive garbage has disrupted the natural flow of the stream, causing further environmental degradation. The accumulated waste consists of both organic and inorganic materials. Inorganic wastes such as plastic, textiles, thermocol, and shoes are prevalent, along with food waste. The improper disposal of these materials directly into the stream has led to their contamination and subsequent spread along the watercourse. Additionally, the presence of toilet waste and gray water further exacerbates the pollution levels in this area. The disrupted flow of the stream hampers its ability to carry water effectively, leading to stagnation and reduced water quality. The decomposition of organic waste releases harmful pollutants into the water, posing risks to aquatic life and overall ecosystem health. Moreover, the foul odor emanating from the area due to the decay of organic matter creates an unpleasant and unsanitary environment for residents and visitors.

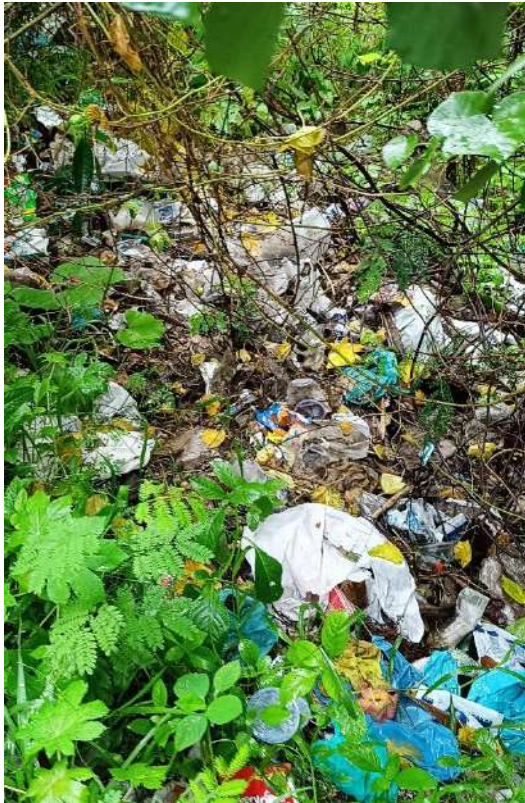
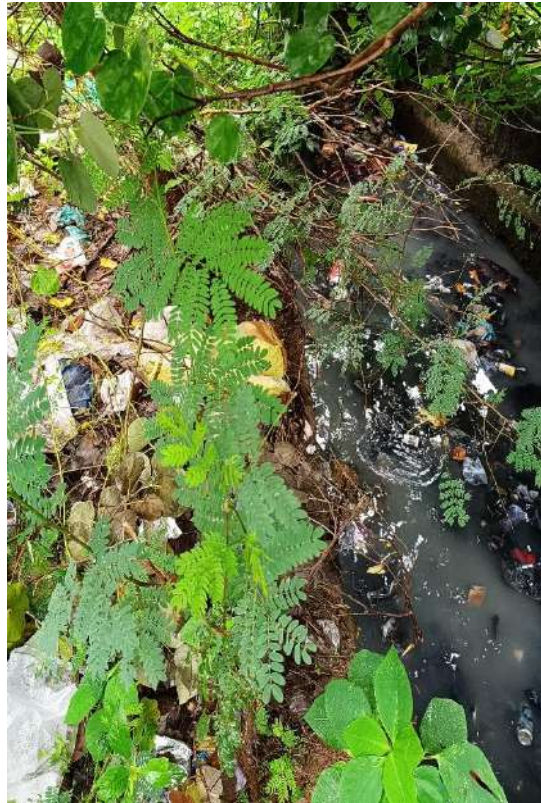
Fig 1.8: Location 12: Manichithodu – behind Pullikada Colony

The stream running through both sides of the open-air auditorium and park eventually flows into the Ashtamudi lake. The stream passes through several slum areas, including Pullikada Colony, Shanti Nagar, and Shankar Nagar. These areas are characterized by a high population density. In this part of the stream, commercial complexes and various establishments are situated along the canal banks. These include businesses, shops, and other commercial activities. A significant amount of garbage has accumulated near the point where the Manichithod stream merges with the Ashtamudi backwater. The presence of such large quantities of waste poses a threat to the water quality and ecosystem of the Ashtamudi backwater. The accumulated waste and polluted water from the Manichithod stream directly flow into the Ashtamudi backwater, resulting in pollution of this important water body. Excess water flow during rainy periods, tidal activity, and wind currents significantly contribute to the dispersion and accumulation of waste in the Ashtamudi lake.

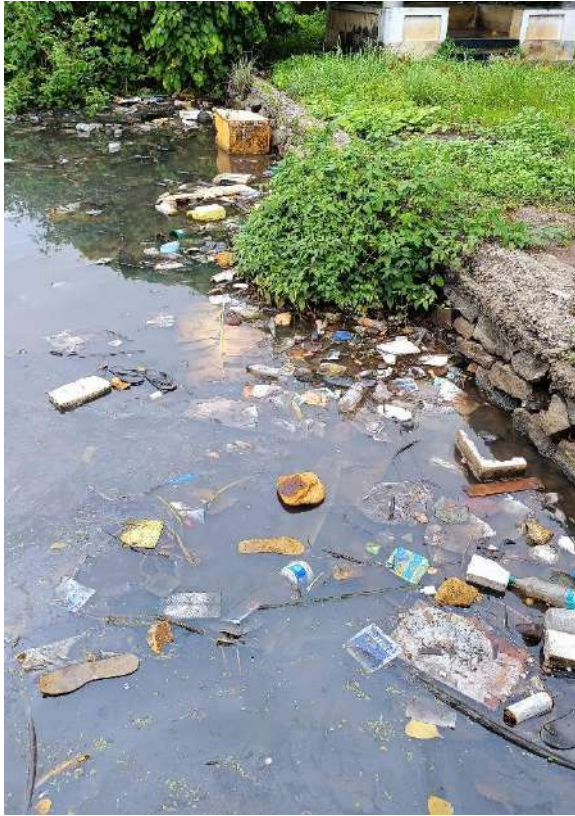
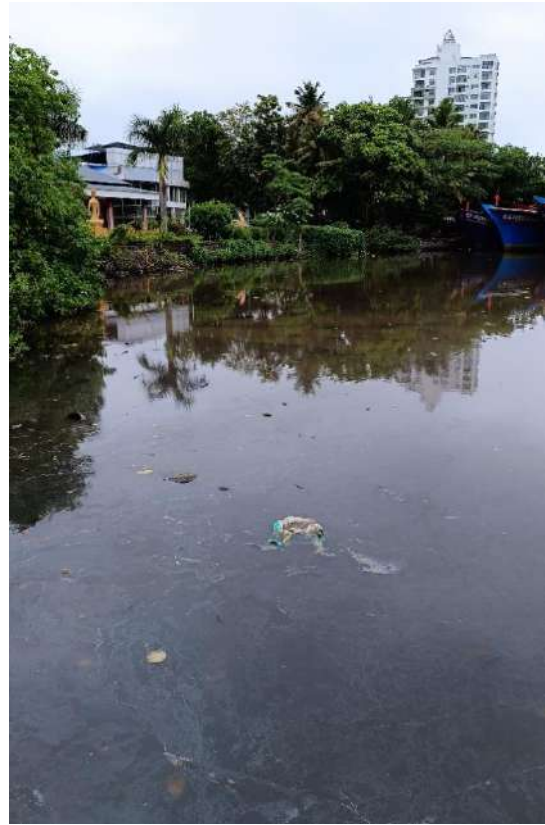
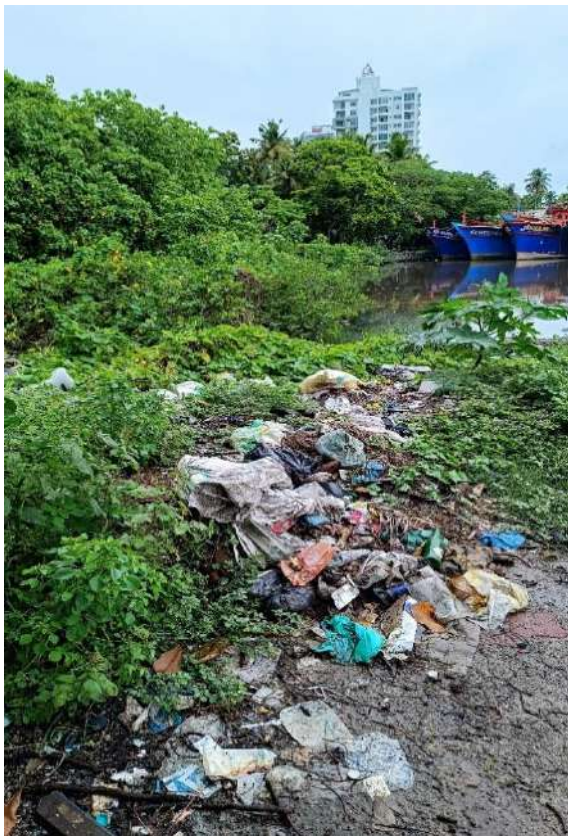
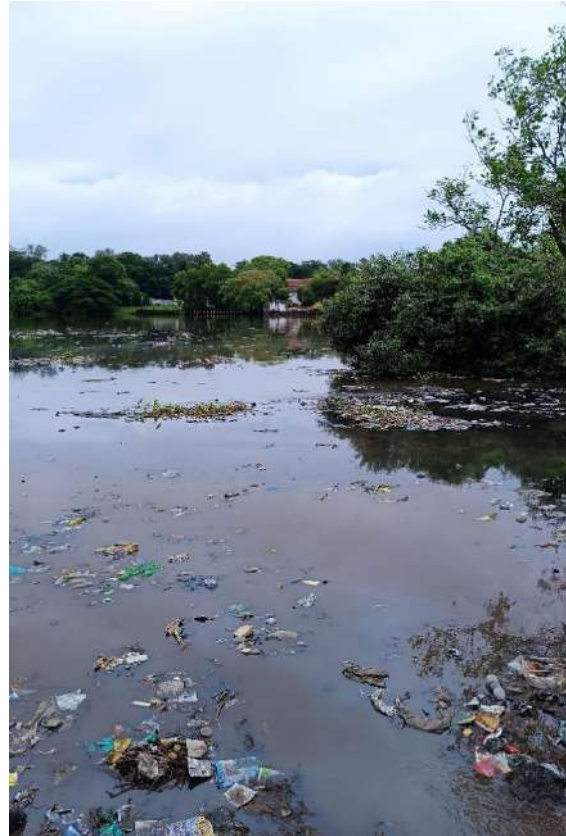
Fig 2.1: Location 15: Thoppilkadavu

Thoppilkadavu, located near Kollam Collectorate on the shores of Ashtamudi Lake, is an area where a significant amount of garbage has accumulated along the lake's shoreline. In this particular part, the presence of natural watercourses is not evident. However, the area is impacted by the presence of sewage and oil, which further contribute to the pollution of the surroundings. It is important to address these issues to prevent further degradation of the lake's ecosystem and ensure the overall well-being of the environment. Additionally, it should be noted that fishing boats operate in close proximity to this area, and there are resorts and establishments situated along the backwaters.

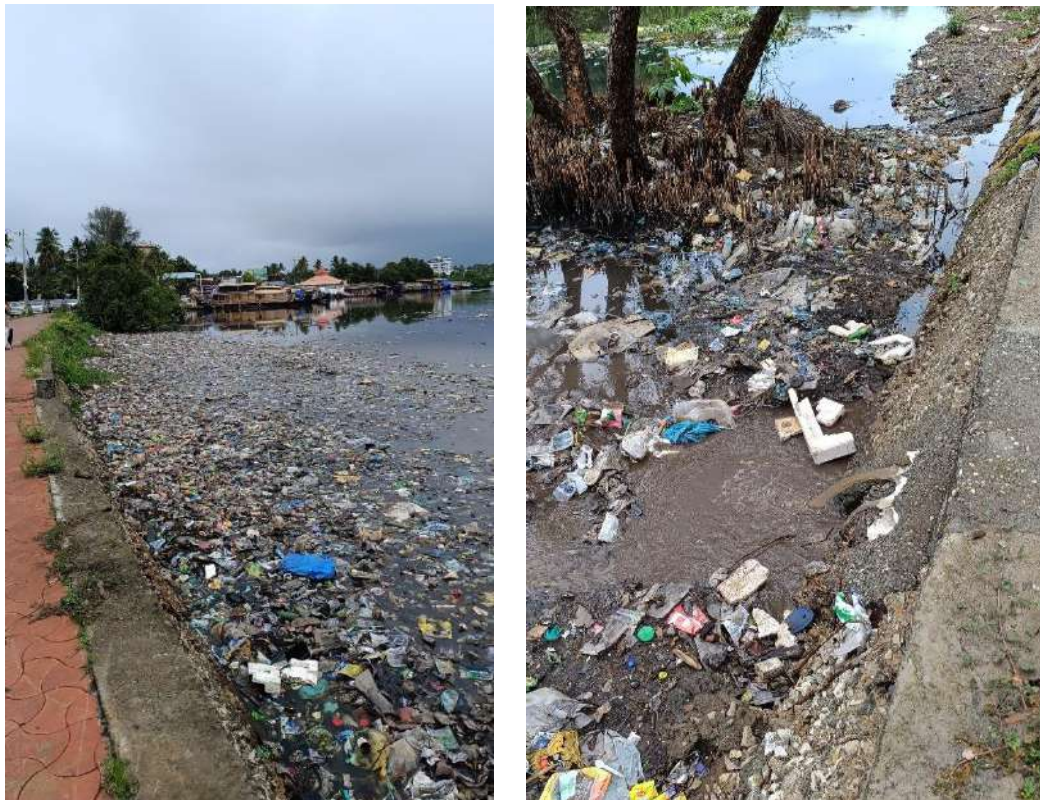
Fig 2.1: Location 15: Ashtamudi Lake

There is a noticeable accumulation of non-degradable waste in the backwaters. The shoreline is littered with such waste, and floating debris can often be observed scattered across the backwaters.

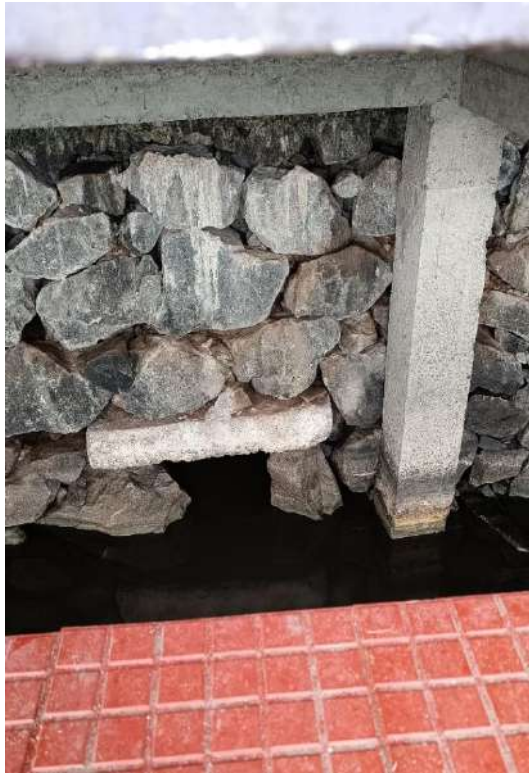
Along the Link Road that runs parallel to Ashtamudi Lake, specifically from the Kollam KSRTC station area to Ashrama Ground, it has been observed that there are four sewage outlets visible underneath the road. It is of great importance to note that these outlets are currently not closed or sealed, which raises concerns regarding the release of untreated wastewater into the lake. Two prominent locations where these outlets can be observed are in front of Poilkada, near the houseboats terminal, and under the platform of Boat Jetty Terminal. Another noticeable spot to witness these outlets is in front of the KSRTC bus stand.

The presence of wastewater flowing into the lake through these outlets is evident, highlighting a significant source of pollution. However, the exact origin of this wastewater remains unclear and requires further investigation to identify and address the sources effectively. It is crucial to take immediate action to prevent the discharge of untreated sewage into the lake and ensure the implementation of appropriate sewage treatment measures. Furthermore, in the vicinity of Ashtamudi Lake, near the KSRTC Garage and Bus Terminal, Poyilakada Fisheries Private Ltd., RP Mall, District Hospital Kollam, and various other institutions and commercial establishments

Fig 2.2: Location 15: Sewage outlets under the platform of Boat Jetty Terminal & KSRTC Bus Station

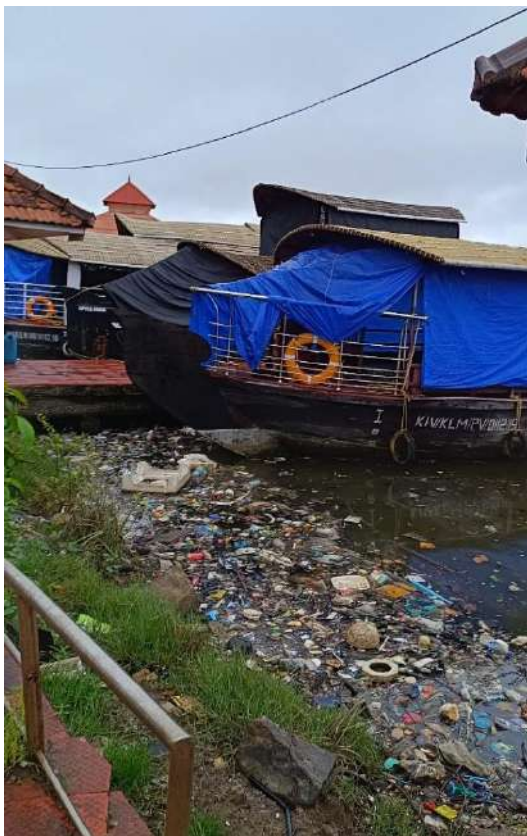
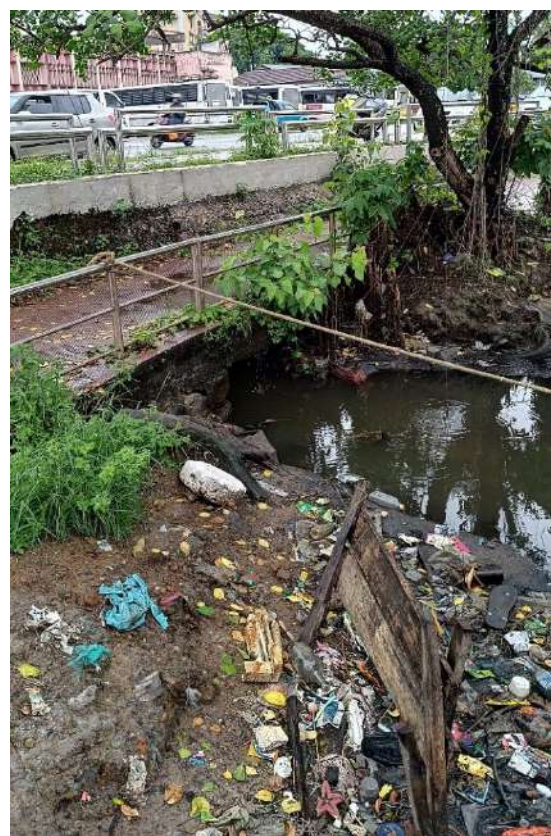
Fig 2.3: Location 15: Sewage outlets near House Boat Jetty Terminal

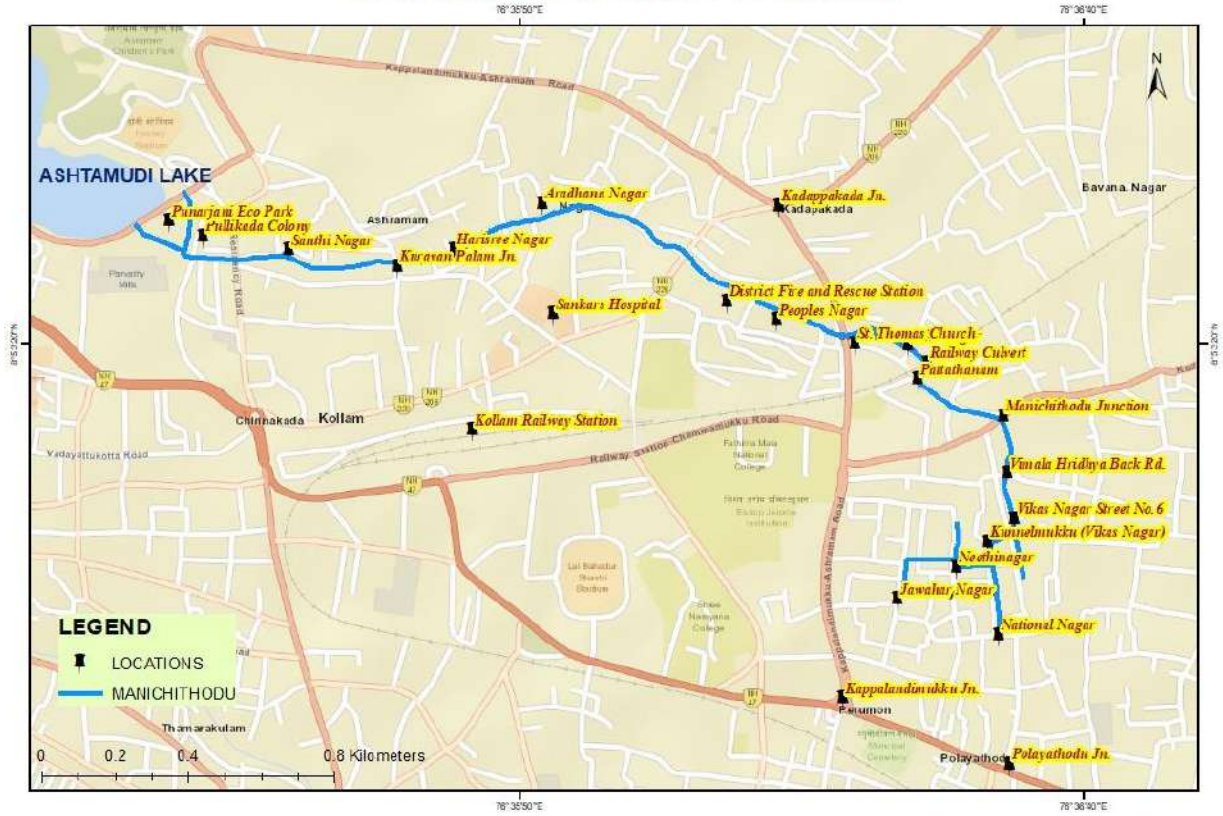
Fig 3.1: Manichithodu – Drainage course Map

Given that Manichithodu flows entirely through the urban and densely populated areas of Kollam corporation, and pollution levels are found to be high. Unfortunately, the stream has been utilized as a dumping site for sewage and various other forms of waste.

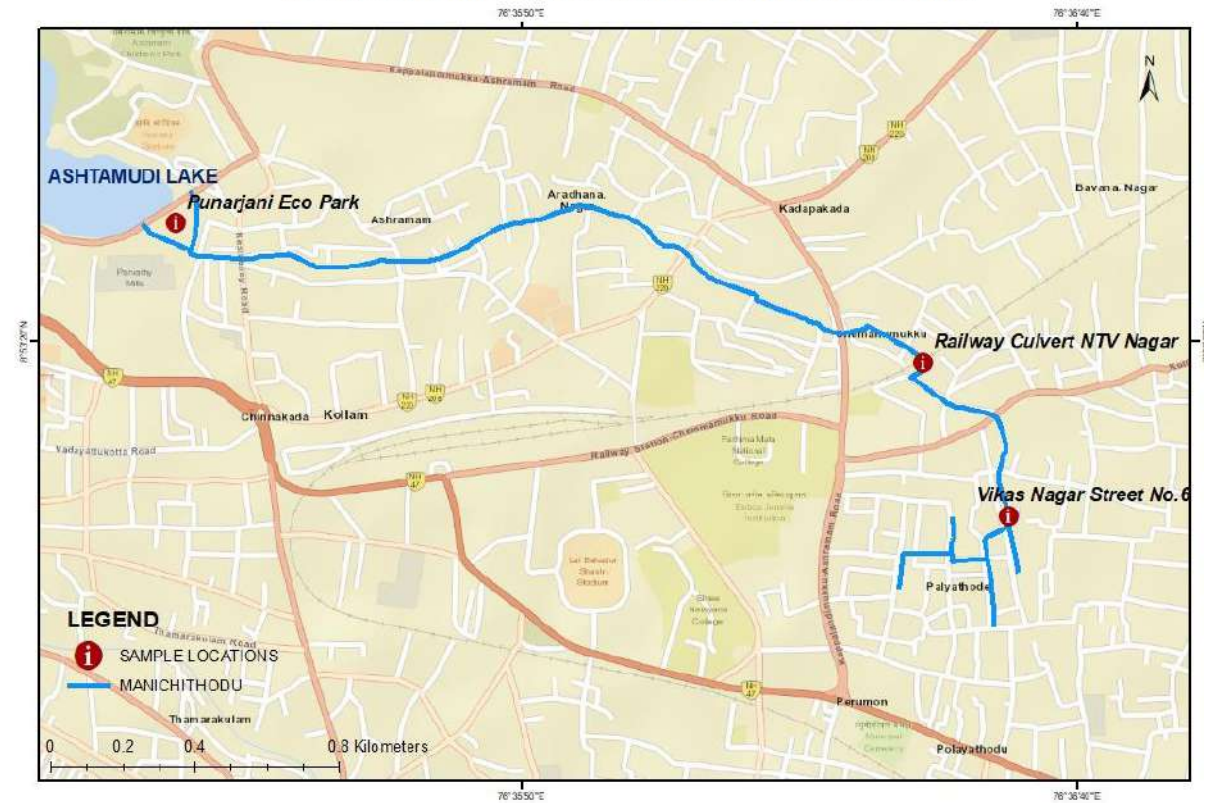
Fig 3.2 Manichithodu – Water Sample Collection Sites

<b>ANALYSIS REPORT OF MANICITHODU ON 12/06/2023</b>					
<b>Sl.no</b>	<b>Parameters</b>	<b>Unit</b>	<b>Manichithodu-Starting Point</b>	<b>NTV Nagar</b>	<b>Manichithodu-ends on Ashtamudi</b>
1	Odour	–	Agreable	Agreable	Not agreable
2	pH	–	7.4	7.2	7.9
3	Turbidity	NTU	4.9	4.5	6.4
4	Electrical Conductivity	μhos/cm	710.8	657.4	817.3
5	Alkalinity	mg/l	10	9	18
6	Total Hardness	mg/l	130	123	154
7	Calcium Hardness	mg/l	108	95	120
8	Magnesium Hardness	mg/l	22	28	34
9	Chloride	mg/l	60	37	120
10	Potassium	mg/l	10.3	8.6	26.8
11	Sodium	mg/l	33.5	26.8	92.6
12	Total Dissolved solids	mg/l	512.5	473.2	658.2
13	Total Suspended Solids	mg/l	141.8	102.8	168.5
14	Dissolved Oxygen	mg/l	5.8	6.7	3.2
15	BOD	mg/l	1.9	1.2	2
16	Phosphate	mg/l	BDL	BDL	BDL
17	Sulphate	mg/l	5.8	2.1	12.8
18	Total Coliform	TC/100ml	900	600	2400
19	Fecal Coliform	FC/100ml	310	400	1420

The presence of coliform bacteria indicates contamination, predominantly from domestic sewage discharge and improper waste disposal practices. This pollution poses a significant threat to the water quality and the overall health of the ecosystem. It also raises concerns about potential health risks for the local population. The high levels of TDS and electrical conductivity in the water samples suggest a significant load of dissolved substances, possibly originating from industrial activities, agricultural practices, and sewage discharges in the surrounding area. These elevated levels can have detrimental effects on the aquatic ecosystem and may also pose challenges for various water uses.

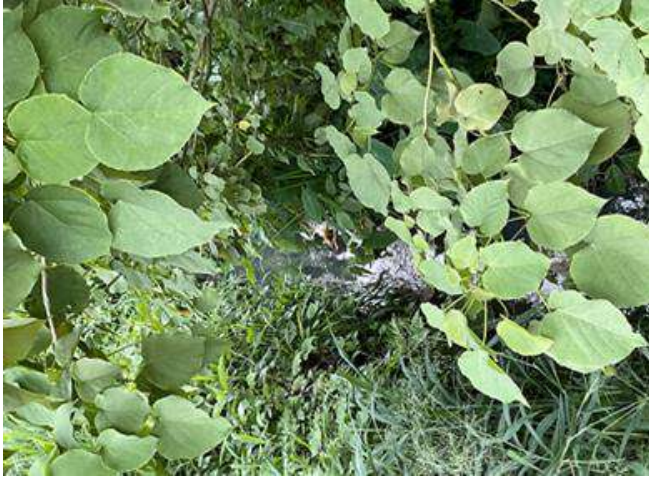
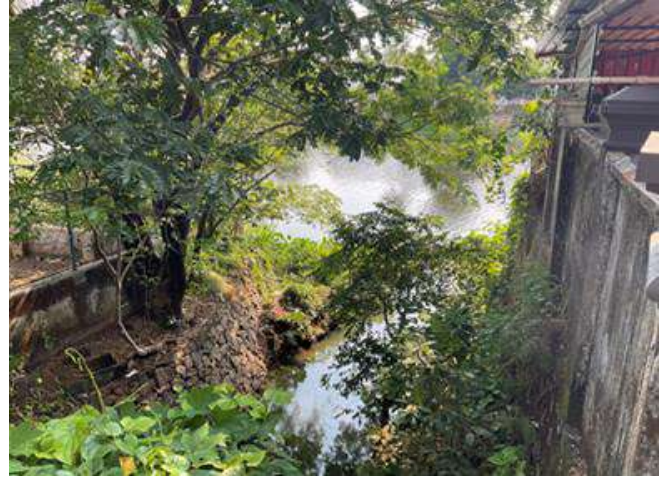
**Plate 1: Canal/drain carrying untreated domestic sewage Aluva Municipal Area**

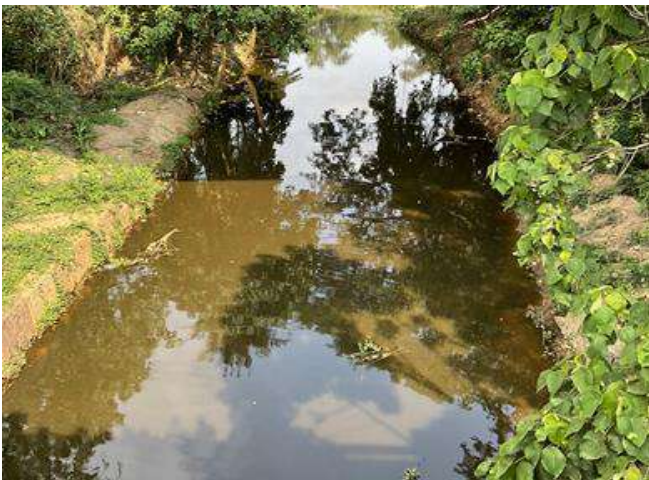
**Plate 2: Canal/drain carrying untreated domestic sewage Kalamassery Municipal Area**

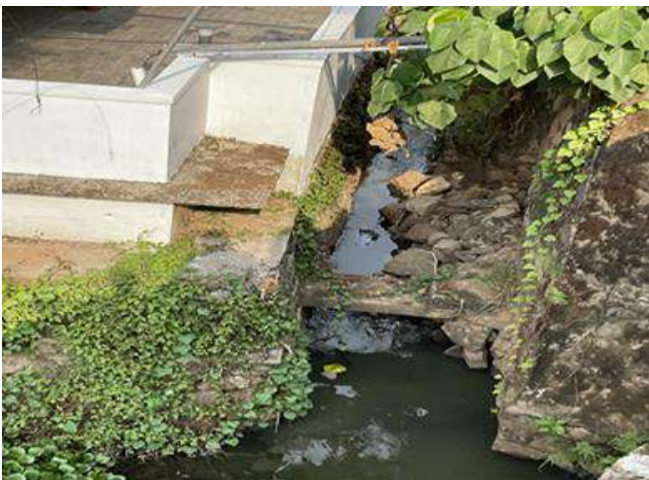
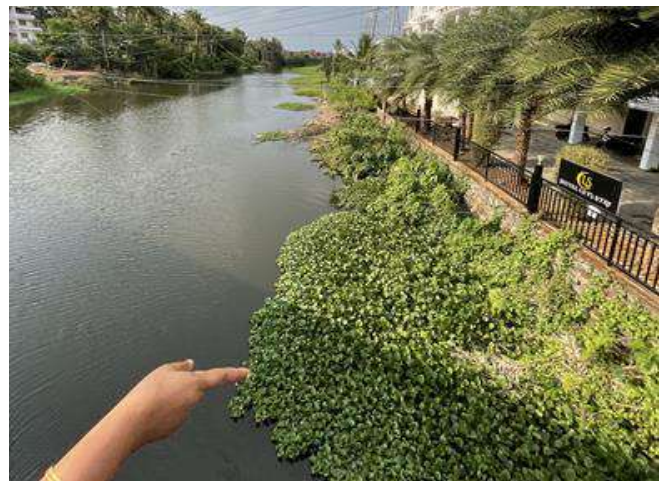
The sewage generated from the Puthlam Kadav Municipality area is discharged into the stormwater canal/drain (Plate 3:Latitude-10°3'47.49" & Longitude-76°19'6.73") which is finally discharged into the Periyar River. The eutrophication and water hyacinth were observed in the Periyar River near the drain confluence with River. There is no STP to treat the sewage generated from PKMA.

**Plate 3: Canal/drain carrying untreated domestic sewage from Puthlam Kadav Municipal area & discharged in Periyar River**

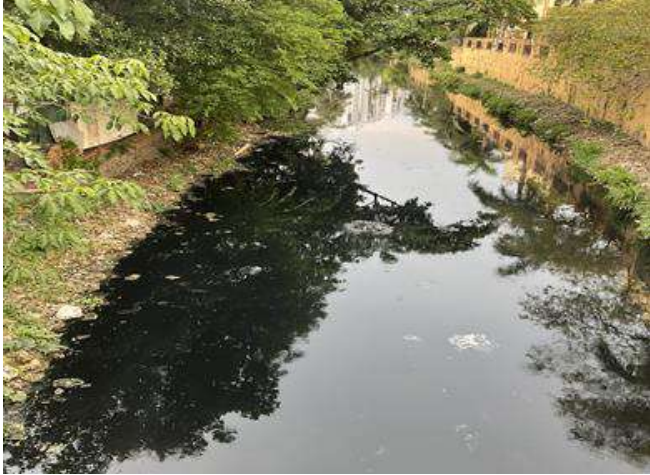
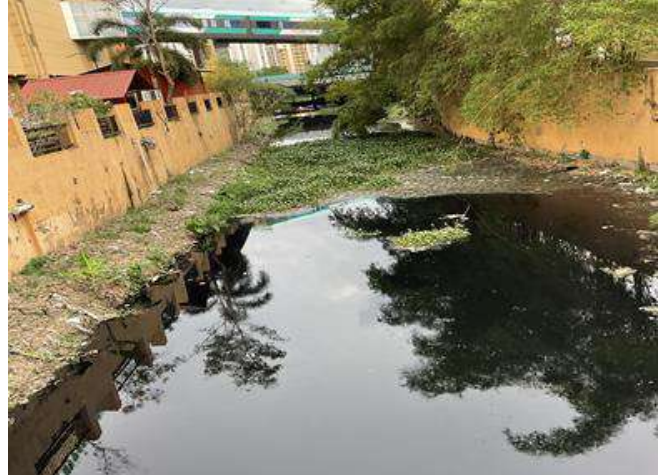
Edapally is the major canal passing through the Edapally and Vitilla zones and confluences to the Perandoor River towards the northern course and the joint Chambakkara canal to the southern end. During the site visit, this canal near Lulu Mall was found in a septic condition as shown in Plate 4:Latitude- 10°1'35.21" & Longitude-76°18'27.45".

**Plate 4: Canal/drain near Lulu Mall carrying untreated domestic sewage**

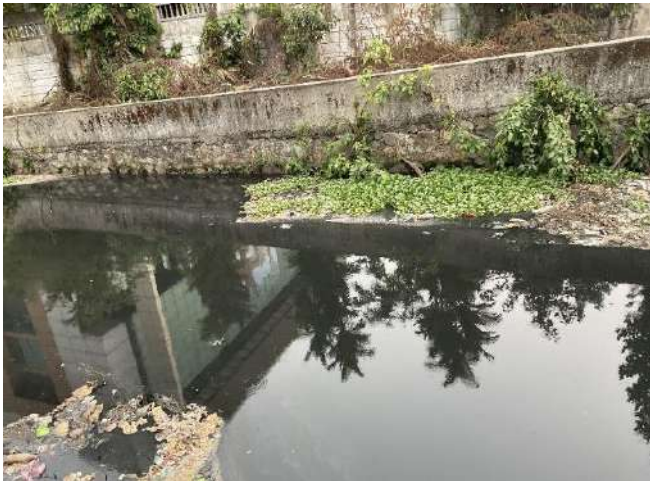
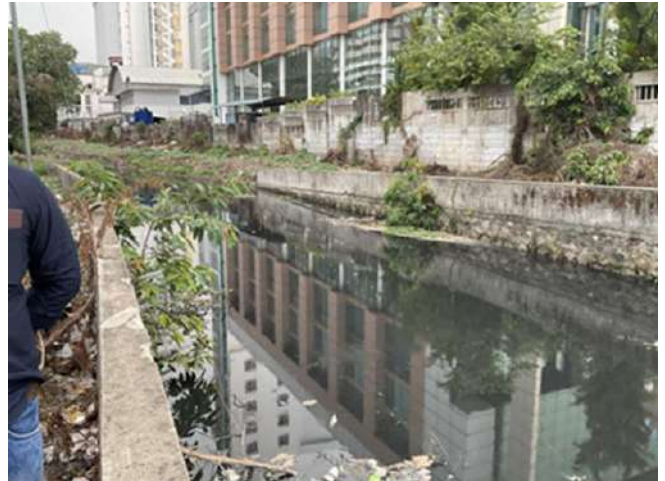
Perandoor canal carries untreated domestic sewage generated from the Kochi Municipal area (Plate 5: Latitude- 9°59'39.75"& Longitude-76°17'25.25") passing through the Edapally, Central, and Vytilla zone of the Kochi Corporation. The slaughterhouse waste and septic condition were observed in the canal (Plate). This canal all the above things and joined to another canal, which confluence to Vembanand Lake.

**Plate 5: Perandoor canal carries untreated domestic sewage generated for the Kochi Municipal area**

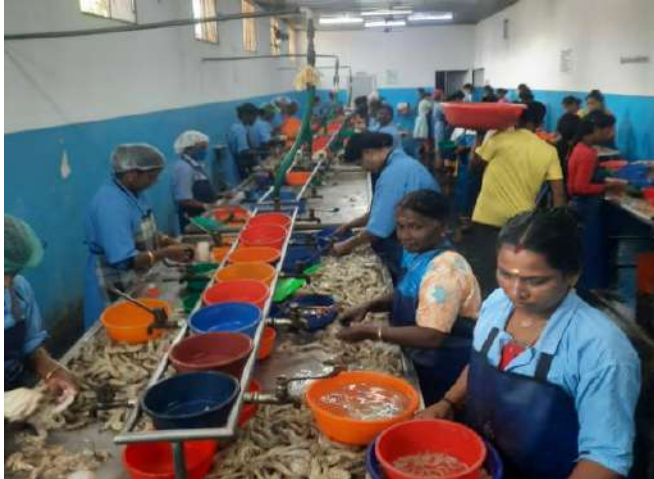
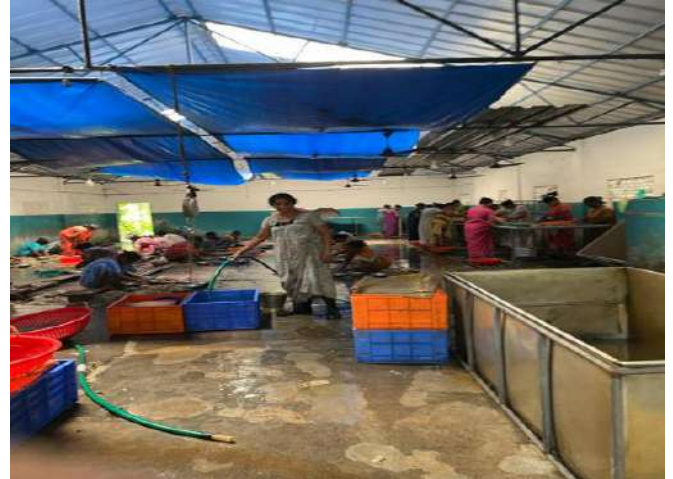
**Plate 6: Prawn peeling activities alongwith floor washing carried out in the industry**

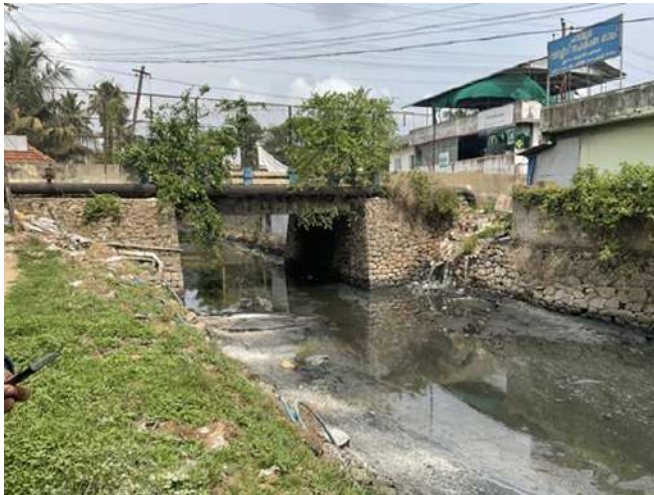
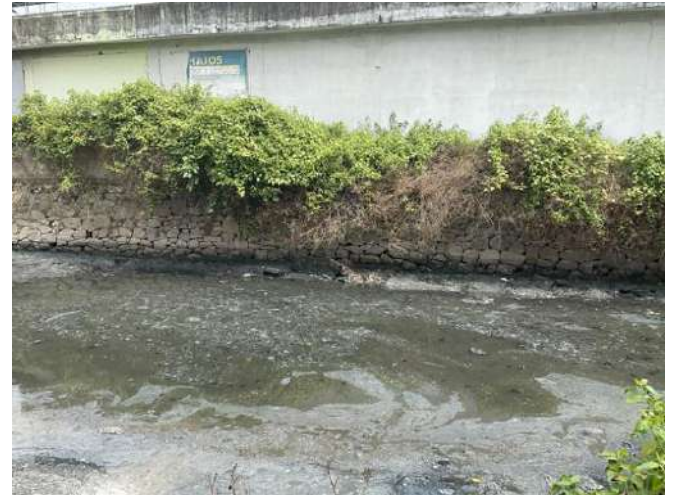
There is no conveyance system or sewage treatment plant (STP) for treating domestic sewage generated from the area and effluent treatment plant/common effluent treatment plant (CETP) for treating effluent generated from the Prawn Peeling Industrial units. The prawn peeling activities along with floor washing are shown in Plate 6: Latitude- 9°59'28.4" & Longitude-76°18'34.4". The untreated sewage and prawn peeling effluent along with its waste are discharged into the Puthenthodu stormwater canal/drain. The condition of the Puthenthodu canal/drain was observed to be septic during the site visit (Plate 7: Latitude- 9°50'28.6" & Longitude- 76°18'34.47").

**Plate 7: Puthenthodu canal/drain carrying the domestic sewage and prawn peeling effluent and its waste**

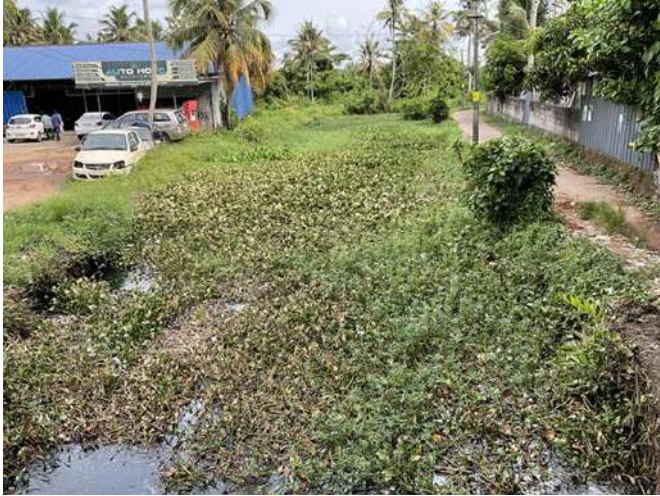
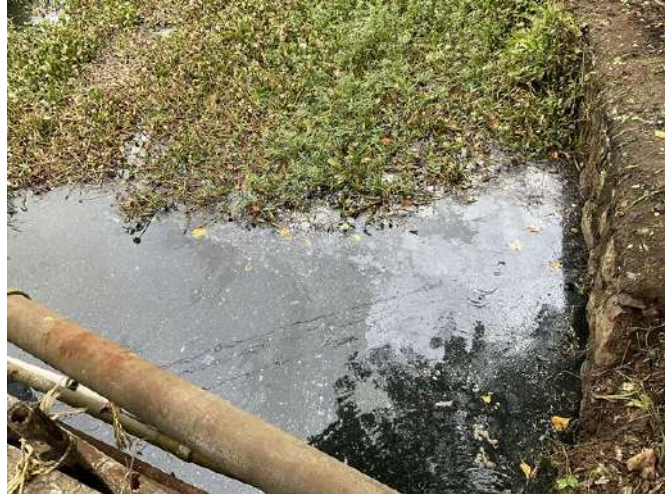
<p>➤ <b>Pattolit canal /drain nallah</b></p> <p>Pattolit canal/drain/nallah carries stormwater and untreated domestic sewage from the habitant of the Karunagapally Municipality area (Plate 8: Latitude- 9°3'23.08" &amp; Longitude-76°32'41.77"), which is finally discharged into the Pallikal River. During the site visit, the septic condition was observed in the Pattolit canal along the water hyacinth at 500m upstream of the confluence of the Pallikar River with the drain.</p>
<p>➤ <b>Valiyath canal/ drain/nallah</b></p> <p>The overflow of Mundakappadam Lake is discharged into the Vallakadavu canal/drain. This drain (Plate 9: Latitude- 9°3'25.02" &amp; Longitude-76°32'34.50") was monitored near the Thwayba chicken stall namely Valiyath canal/ drain and its condition were similar to Pattolit canal/drain /Nallah except for the water hyacinth.</p>
<p>➤ <b>Canal/drain near Kanneti bridge</b></p> <p>A drain near Kanneti bridge parallel to the abandoned railway line to KMML carried untreated domestic sewage and stormwater and the confluence with the Lake.</p>

**Plate 8: Pattolit canal/drain/nallah carries stormwater and untreated domestic sewage from Karunagapally Municipality area**

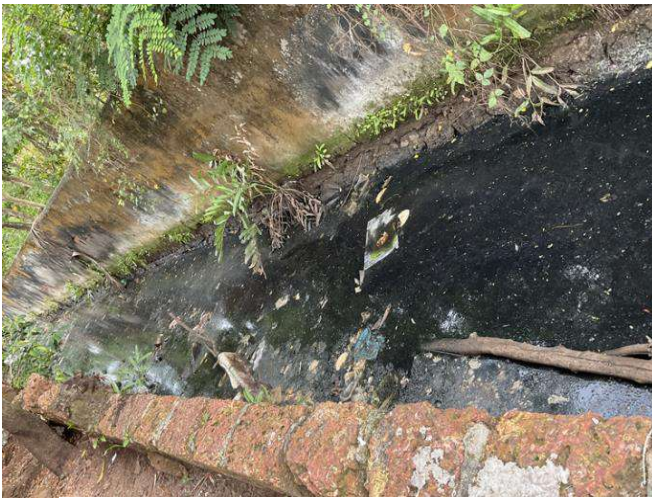
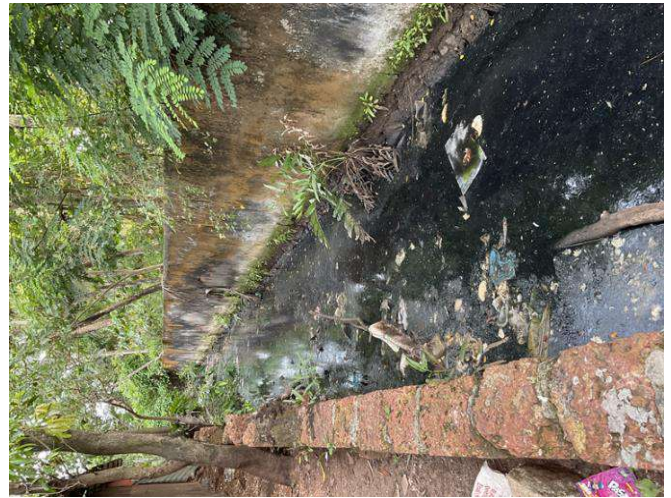
**Plate 9: Valiyath canal/ drain/nallah carrying the untreated domestic sewage**

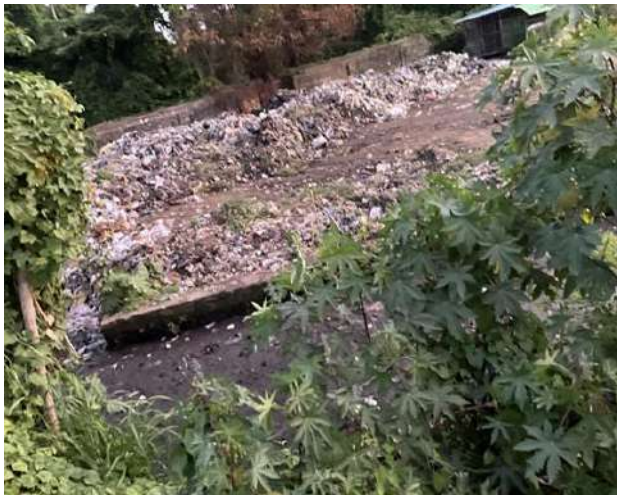
The untreated domestic sewage and solid & plastic wastes from the Manichithodu slum area are directly discharged into the drain, which is finally discharged into Asthamudi Lake. The condition of the drain and Asthamudi Lake was septic as shown in Plate 10 Latitude-  $9^{\circ}53'29.61''$  & Longitude- $76^{\circ}35'16.90''$ .

**Plate 10: Canal/ drain/nallah carrying the domestic sewage from Manichithodu Slum area and discharged into Asthamudi Lake**

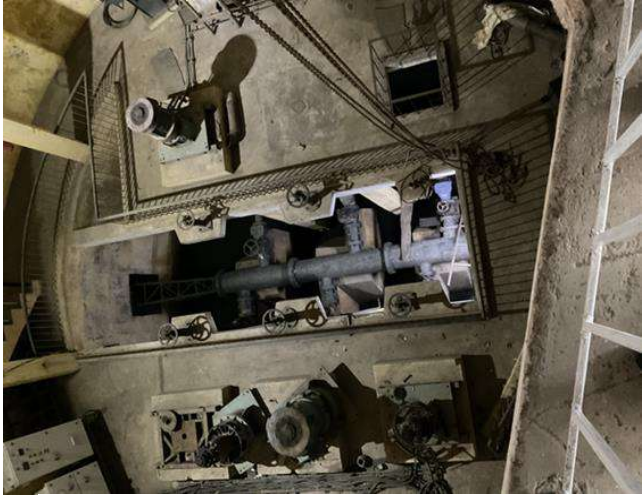
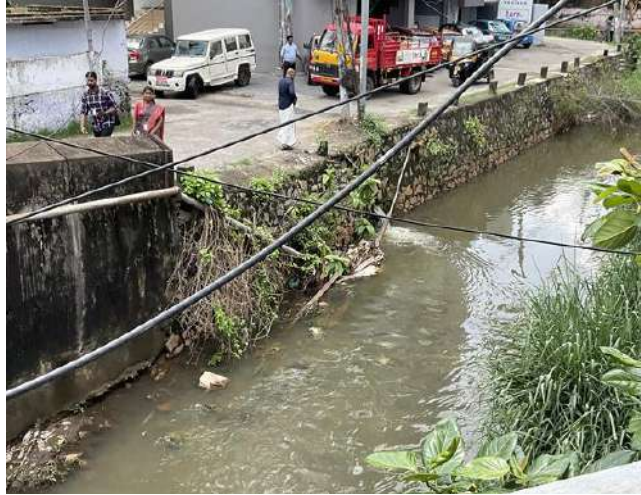
<p>➤ <b>Pattom sewage pumping stations</b></p> <p>Pattom pumping station (Plates 11 Latitude- 8°30'55.36" and Longitude-76°56'43.43" &amp; 12 Latitude- 8°29'52.57" &amp; Longitude-76°56'4.35") collected raw sewage from the nearby municipalities area and pumped it to the existing 107 MLD sewage treatment plant. Pottam pumping station is facilitated with six pumps out of which two pumps were operational and four were under maintenance or non-functional. Due to the non-operational of four pumps, the sewage is continuously bypassed to an adjacent drain. During the visit, local people were complaining about the discharge of sewage into the canal/drain from the pumping station.</p>
<p>➤ <b>Pattoor sewage pumping station</b></p> <p>Pattoor pumping station also collected raw sewage from the nearby municipalities area and pumped it to the existing 107 MLD sewage treatment plant. This pumping station consists of four pumps out of which one submersible pump was operational and three non-submersible pumps were in scrab. Due to the non-operational of three pumps (Plate 12 Latitude- 8°29'52.57"&amp; Longitude-76°56'4.35"), the sewage is continuously bypassed to an adjacent drain (Plate 13 Latitude 8°29'54.09" &amp; Longitude-76°56'12.00"). One of the sewerage lines should carry the sewage to the pumping station but due to the drain/canal in between the sewage line is not laid up to the pumping station. Entire sewage from this sewerage line is discharged into the canal/drain.</p>

**Plate 11: Pattom sewage pumping station discharging overflow into canal/ drain/nallah**

- The practice of discharging houseboats sewage/septage into the Vembanadu Lake must be stopped and treated in an adequate treatment plant.
- The discharge of raw sewage from the Pattom and Pattoor pumping stations must be immediately stopped to protect the water quality of the canals/drains. It is recommended that the existing pumps must be repaired/replaced with new pumps of adequate capacity. The entire raw sewage from both pumping stations must be pumped to the existing 107 MLD STP for treatment.

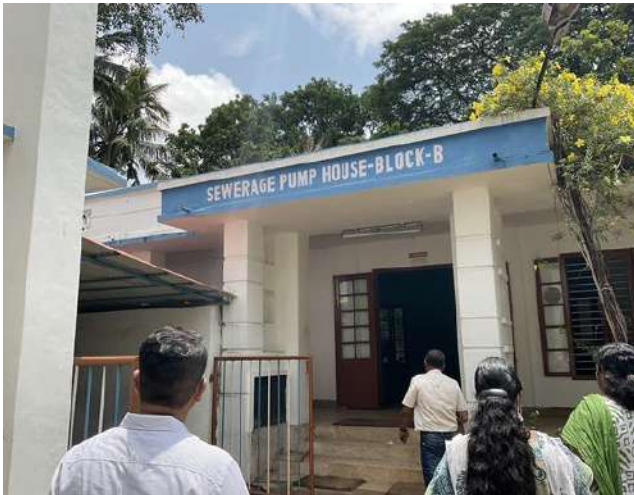
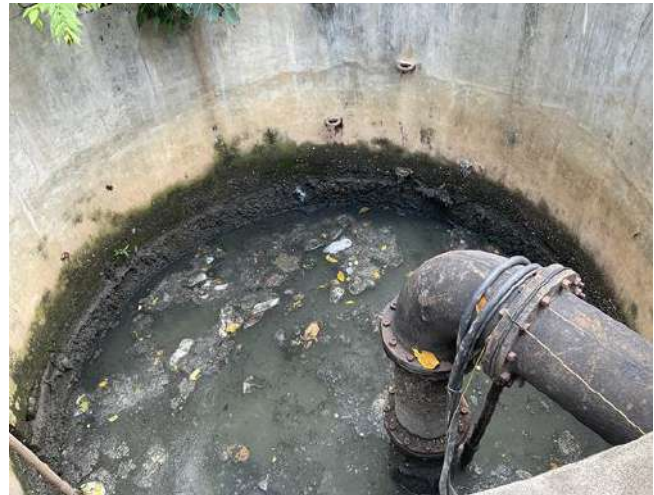
**Plate 12: Pattoor sewage pumping station**
