**Minutes of the meeting held on 20.05.2023 by the Managing Director in the chamber of Chief Engineer (CR), Kochi regarding the co-treatment of septage at Elamkulam STP, Kochi**

**ബഹു. ദേശീയ ഹരിത ട്രൈബ്യൂണലിന്റെ OA 673/2018 ഉത്തരവ് അനുസരിച്ച് പെരിയാർ നദിയുടെ ഗുണനിലവാരം മെച്ചപ്പെടുത്തുന്നതിനായി തയ്യാറാക്കിയ കർമ്മപദ്ധതി നടപ്പിലാക്കുന്ന തുമായി ബന്ധപ്പെട്ട് 26.05.2023 - ൽ District Level Technical Committee (DLTC) അംഗങ്ങളുമായി വീഡിയോ കോൺഫറൻസ് മുഖാന്തരം നടത്തിയ യോഗത്തിന്റെ മിനിറ്റ്സ്**

The Hon'ble NGT on 22/03/2022 in OA 147/2022 observed high Biochemical Oxygen Demand (BOD) levels in Ashtamudi at Thoppilkadavu and KSRTC. As a result, the NGT directed the identification of pollution sources and implementation of remedial measures.

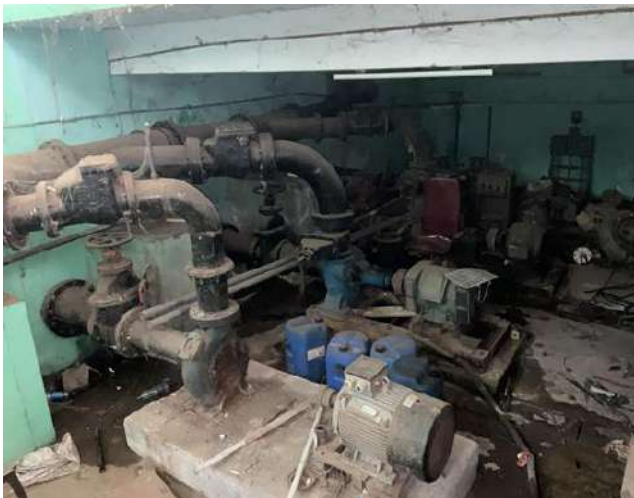
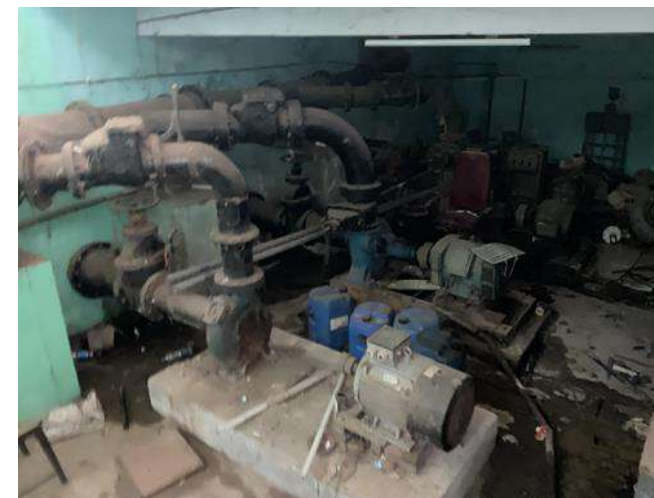
**Plate 13: Pattoor sewage pumping station, pump not in working condition or scrab**

- The practice of discharging houseboats sewage/septage into the Vembanadu Lake must be stopped and treated in an adequate treatment plant.
- The discharge of raw sewage from the Pattom and Pattoor pumping stations must be immediately stopped to protect the water quality of the canals/drains. It is recommended that the existing pumps must be repaired/replaced with new pumps of adequate capacity. The entire raw sewage from both pumping stations must be pumped to the existing 107 MLD STP for treatment.

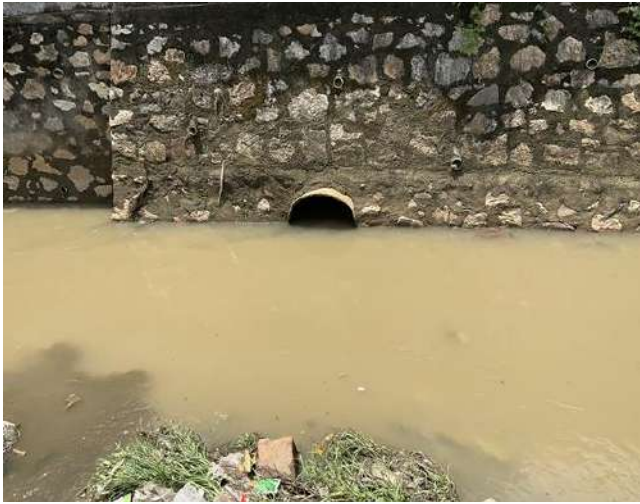
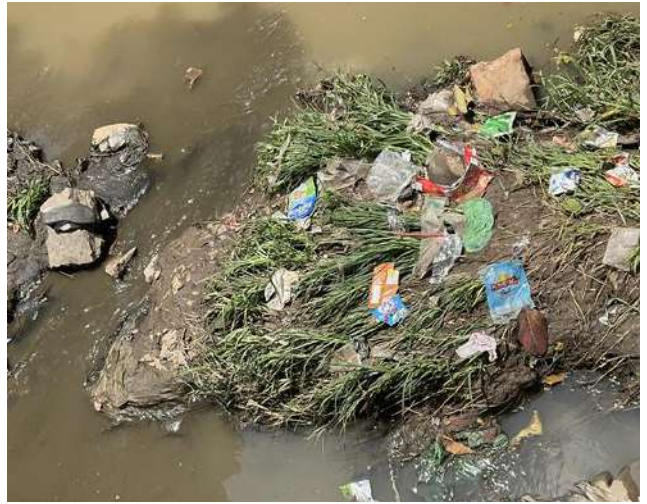
**Plate 14: Overflow of sewage from Pattoor sewage pumping station in to the canal, drain/nallah**

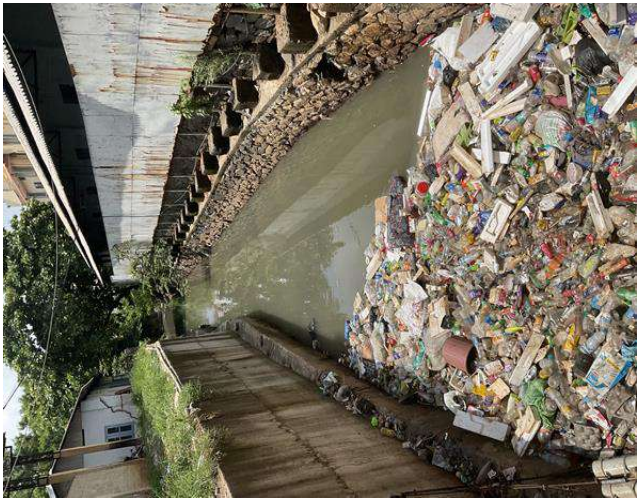
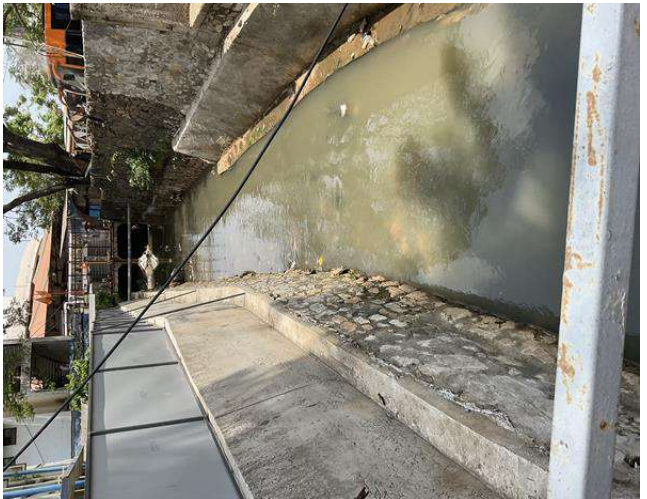
<p>➤ <b>Drain near Kerala State Road Transport Workshop</b></p> <p>The drain near the Kerala State Road Transport workshop carries domestic sewage from the slum area (Plate 15 Latitude 8°29'22.54" &amp; Longitude-76°57'8.09").</p>

**Plate 15: Canal/drain/nallah near KSRT carrying the domestic sewage from slum area**
