ACTION PLAN FOR RESTORATION OF POLLUTED  
LOCATION, PULIKKAKADAVU IN RIVER  
CHALAKKUDY, THRISSUR – KERALA  
(PRIORITY-V)

(OA No.673/2018)

District Level Technical Committee  
(Thrissur District)

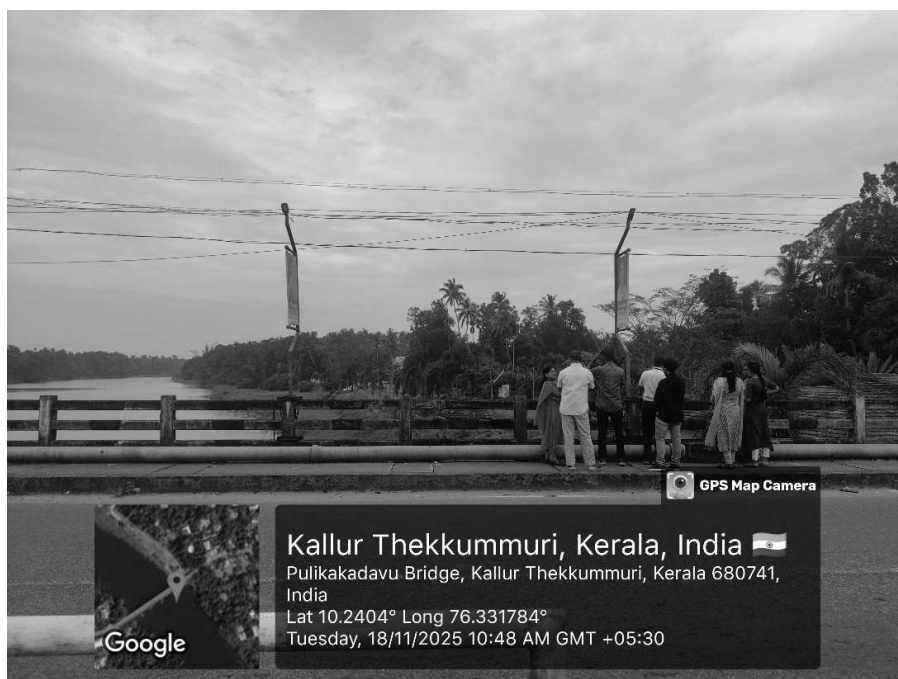
A joint inspection was carried out at Pulikkakadavu Bridge (Lat: 10.2404° Long: 76.331784°) on 18 November 2025 with the specific objective of identifying potential sources of pollution, particularly those contributing to elevated total coliform concentrations. The inspection revealed that no major drains or outfalls discharging pollutants into the water body

are present in the immediate vicinity of the bridge. Moreover, no visible effluent discharges, sewage inflows, or solid waste dumping activities were observed during the site visit.

Joint inspection conducted at Pulikkakadavu bridge on 18.11.2025

| Activity | Implementing Agency | Cost (Rs. Lakh) | Source of Fund | Timeline | Expected Outcome |
|---|---|---|---|---|---|
| Strengthening night-time surveillance along the Pulikkakadavu bridge and riverbank | Annamanada Gramapanchayat<br>h & Police Department | --- | LSGD funds | --- | Prevention of illegal waste dumping and identification of intermittent pollution sources |
| Installation of CCTV cameras | Annamanada Gramapanchayat | --- | Panchayath Own Fund / | 31.03.2026 | Improved real-time |

| at strategic points (bridge area, riverbank access points, under-bridge area) | h | | State Plan | | monitoring, evidence collection, deterrence of unauthorized activities |

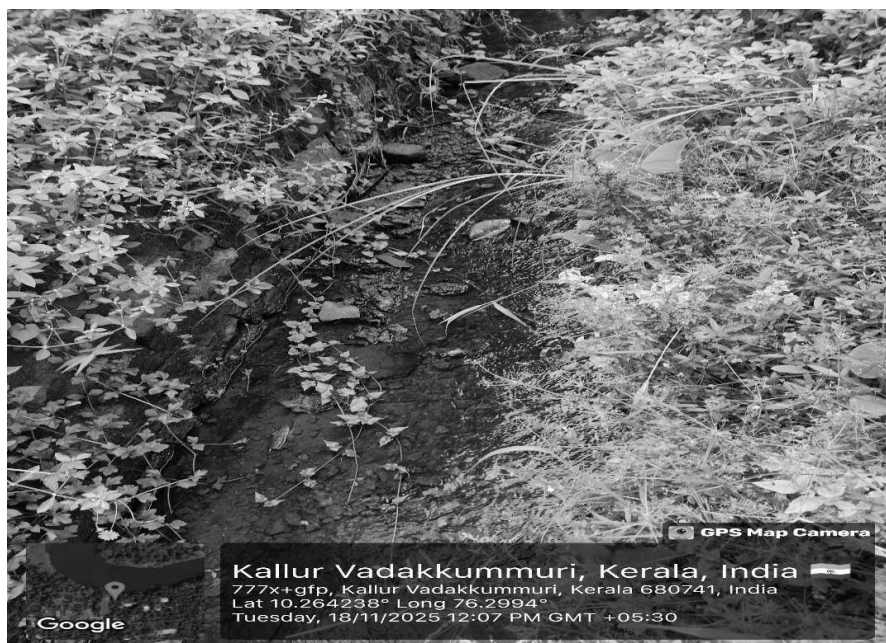
An upstream inspection covering a distance of approximately 1.5 km identified the Kallur Vadakkummuri drain (Lat: 10.264272° Long: 76.299406°) as a possible source. However, field observations indicated the absence of any visible waste disposal or sewage discharge to the drain. Subsequent laboratory analysis (Table.5) of samples collected from the drain further confirmed that it does not make a significant contribution to the overall pollution load, including Total Coliform contamination, at the Pulikkakadavu monitoring point.

Drain located at Kallur Vadakkummuri during joint monitoring

| Periodical inspection of Vadakkummuri drain to prevent unauthorized sewage connections | LSGD (Annamanada GP) & Health Department | --- | LSGD sanitation fund | Monthly | Prevention of domestic sewage mixing into the river; reduction in microbial load |
