ACTION PLAN FOR POLLUTED RIVER STRETCHES

MOGRAL RIVER (PRIORITY V)

KERALA STATE POLLUTION CONTROL BOARD DISTRICT OFFICE KASARAGOD

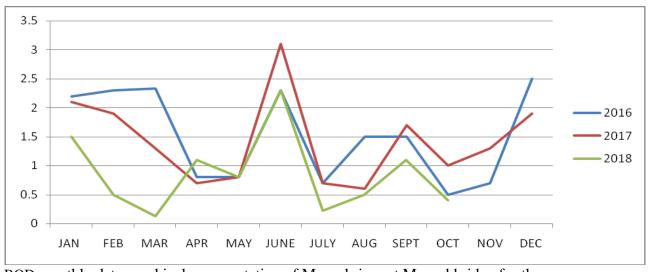
BOD monthly data graphical representation of Mogral river at Mogral bridge for the years 2016, 2017 and 2018

MONTH		JAN	FEB	MAR	APR	MAY	JUNE	JULY	AUG	SEPT	OCT	NOV	DEC
BOD	2016	2.2	2.3	2.33	0.8	0.8	2.3	0.7	1.5	1.5	0.5	0.7	2.5
	2017	2.1	1.9	1.3	0.7	0.8	3.1	0.7	0.6	1.7	1	1.3	1.9
	2018	1.5	0.5	0.13	1.1	0.8	2.3	0.23	0.5	1.1	0.4	1.3	1.3

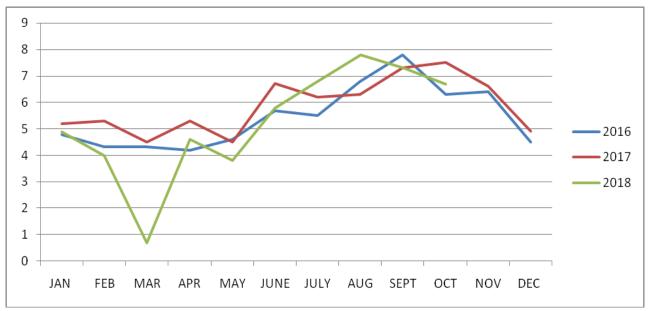
DO monthly data graphical representation of Mogral river at Mogral bridge for the years 2016, 2017 and 2018

JAN	FEB	MAR	APR	MAY	JUNE	JULY	AUG	SEPT	OCT	NOV	DEC
2016	4.8	4.33	4.33	4.2	4.6	5.7	5.5	6.8	7.8	6.3	6.4	4.5
2017	5.2	5.3	4.5	5.3	4.5	6.7	6.2	6.3	7.3	7.5	6.6	4.9
2018	4.9	4	0.7	4.6	3.8	5.8	6.8	7.8	7.3	6.7	5.8	5.6

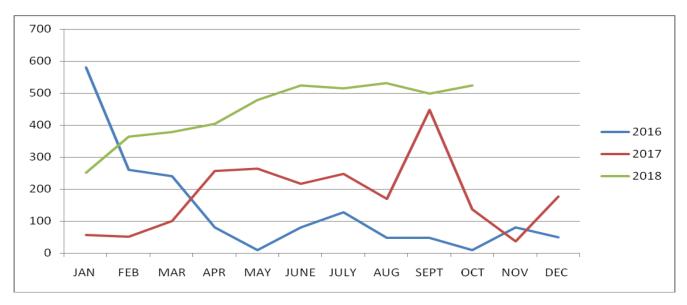
FC monthly data graphical representation of Mogral river at Mogral bridge for the years 2016, 2017 and 2018

JAN	FEB	MAR	APR	MAY	JUNE	JULY	AUG	SEPT	OCT	NOV	DEC
2016	580	260	240	80	10	80	128	48	48	10	80	50
2017	56	50	100	256	264	216	248	169	448	136	36	176
2018	252	364	380	404	480	524	516	532	500	524	380	390

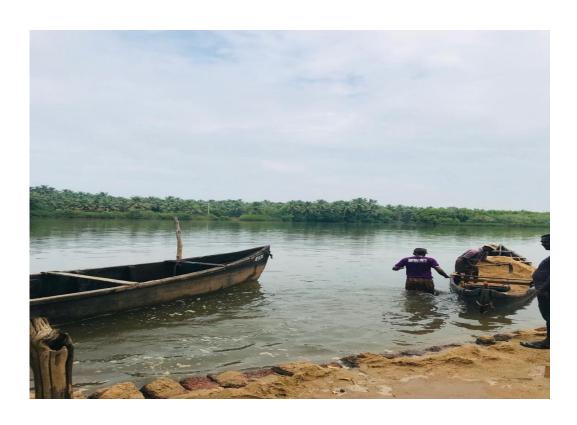
Sand mining

The Mogral River flows mainly through the Mogral – Puthur, Kumbala, Madhur and Chengala grama panchayaths. In Mogral – Puthur panchayath, it was informed that often solid wastes were dumped into the river from the highway bridge at Mogral into Mogral river. The local Panchayath is planning to install a CCTV in order to track the waste dumping activity. It was told that regular inspection and strict warnings are being given to local slaughter houses to reduce waste dumping. Sand mining is being carried out widely in the river, and also close to our NWMP sampling station.
