ACTION PLAN FOR TIRUR- PONNANI RIVER

KERALA STATE POLLUTION CONTROL BOARD

JUNE 2019

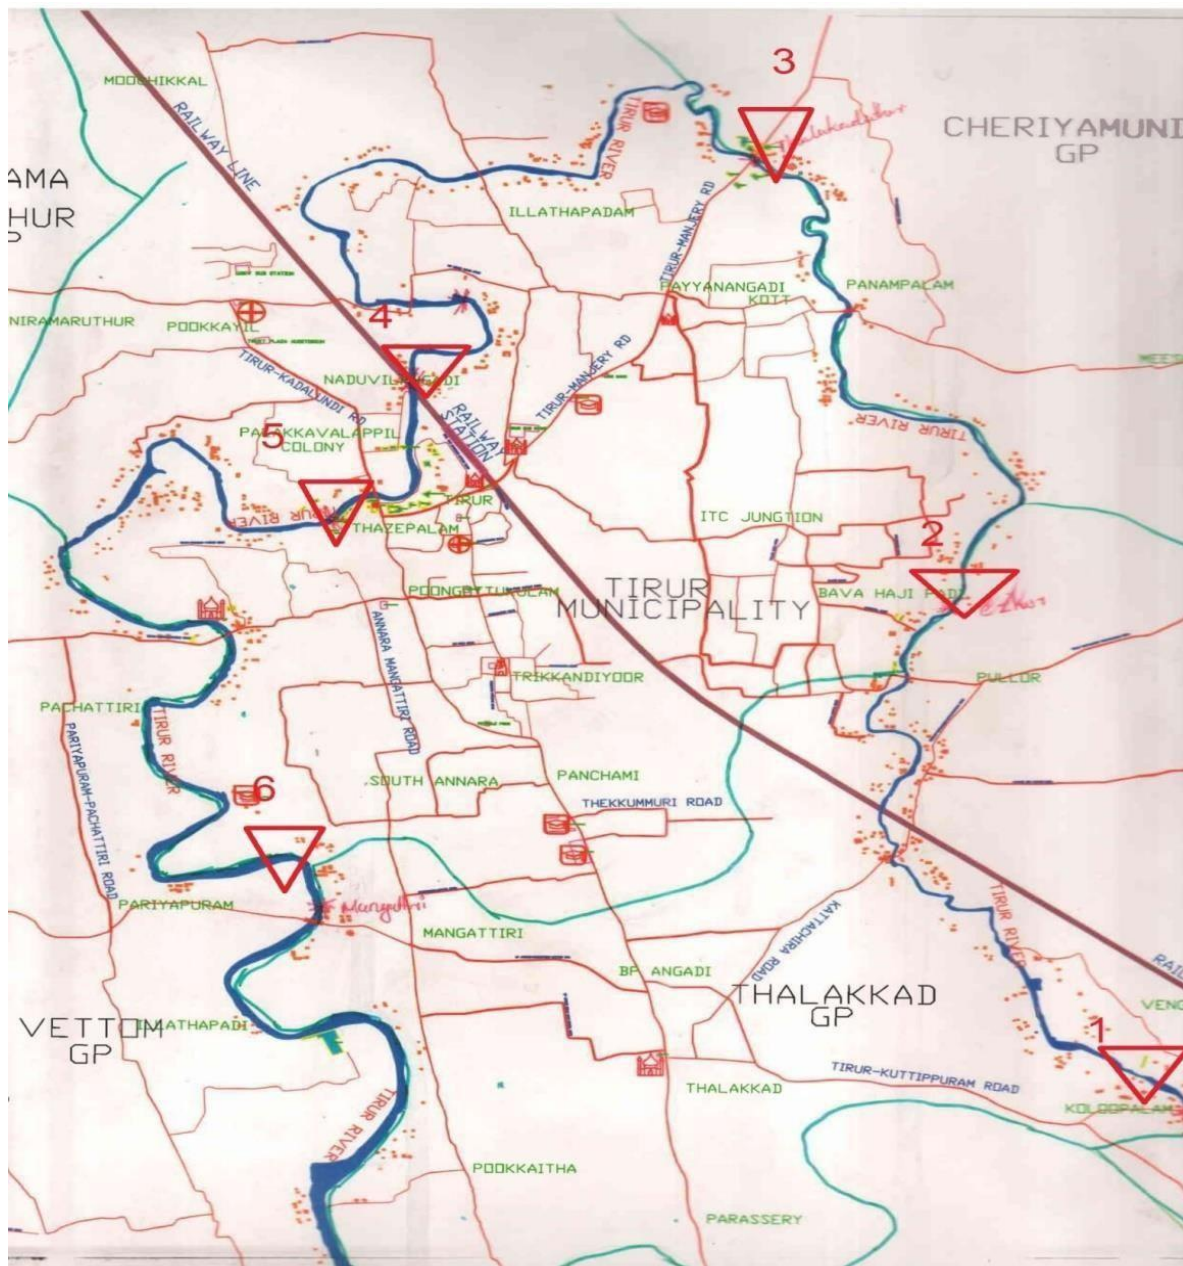
2. NWMP AND SWMP SAMPLING POINTS IN TIRUR- PONNANI RIVER

- 1. KOOLUPALAM**
- 2. EZHUR**
- 3. THALAKADATHUR (NWMP)**
- 4. NADUVILANGADI**
- 5. THAZHEPALAM**
- 6. MANGATIRI**

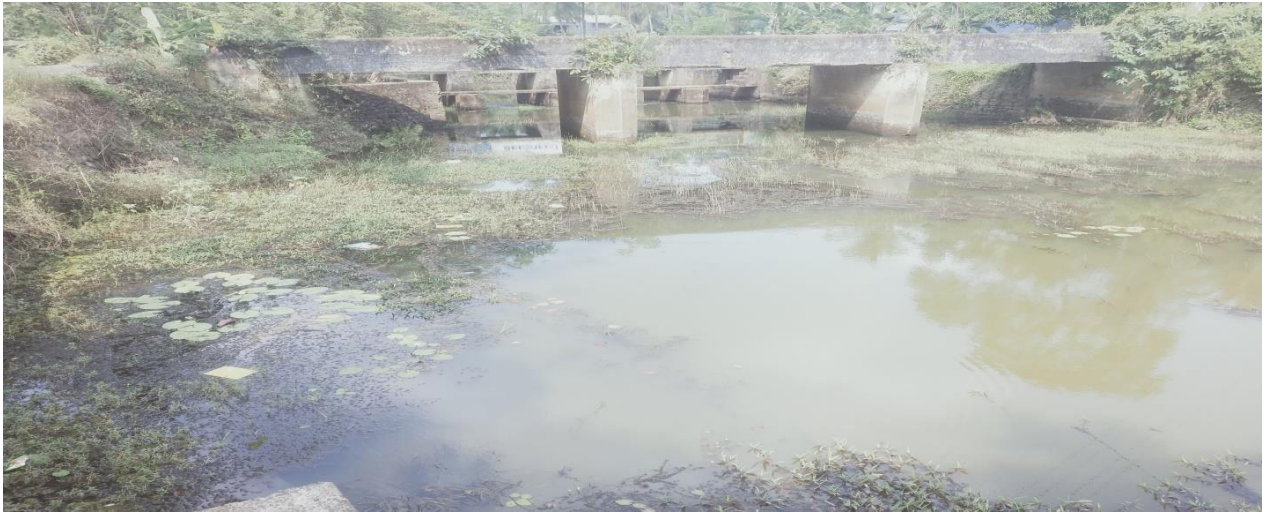
1.KOOLUPALAM

(It is a water pumping point for Thirunnavaya lift irrigation project)

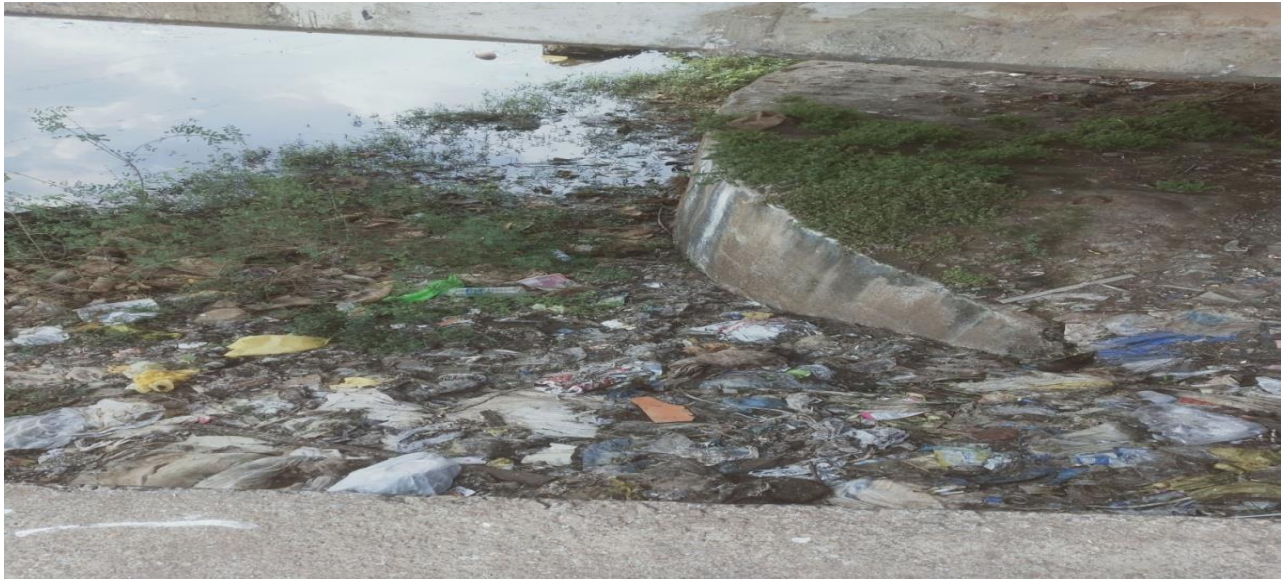
3. THALAKKADATUR (NWMP STATION)

(It is a National Water Monitoring Point station. Also there is KERALA WATER AUTHORITY pumping station)

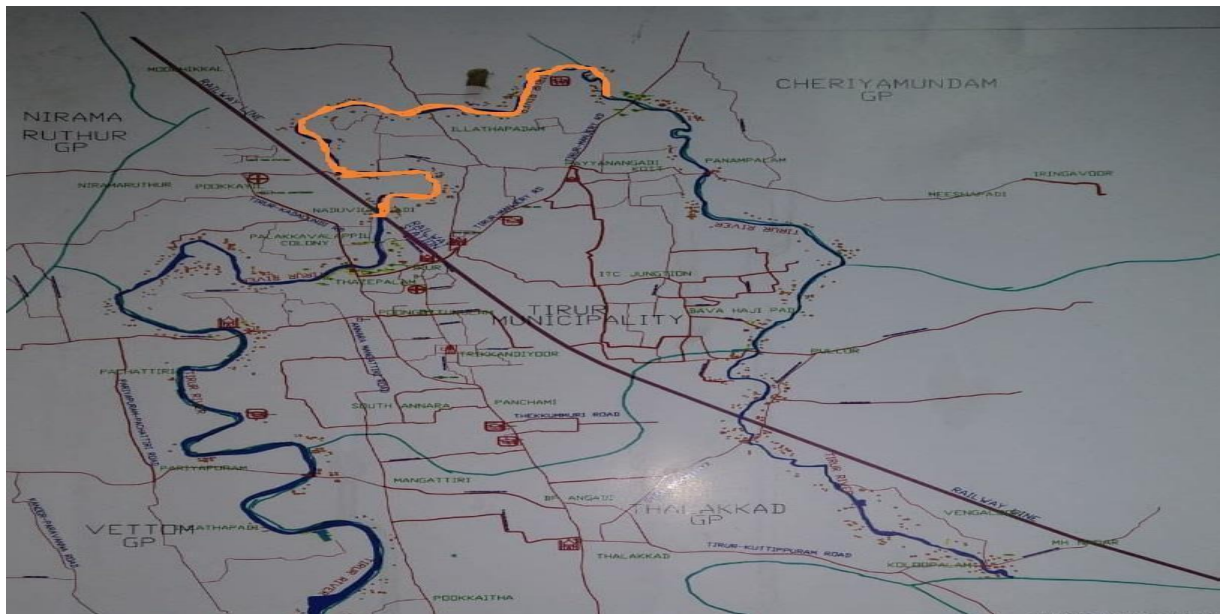
Study area –Identified polluted stretch by CPCB (Naduvilangadi to Thalakkadatur) [Action plan already submitted]
