# KERALA STATE POLLUTION CONTROL BOARD

Sub: OA No. 673/2018 - Polluted River Stretches Program Report - Reg.

# **KARAMANA RIVER ACTION PLAN**

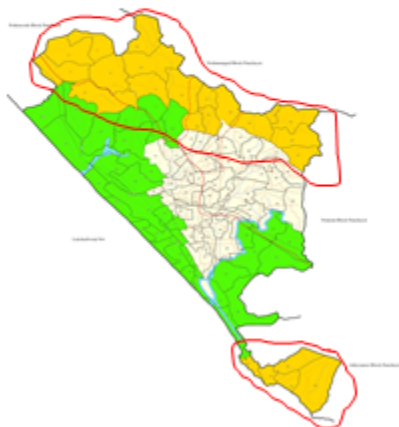
**Solution for uncovered areas - Septage Management**

- o Since no networks are available the ground water pollution/dischage into streams has to be controlled. So the usage of septic tank has to be made mandatory
- o Collection tankers to be arranged by Corporation
- o Construction of septage treatment plant is completed at Muttathara and is ready to receive septage

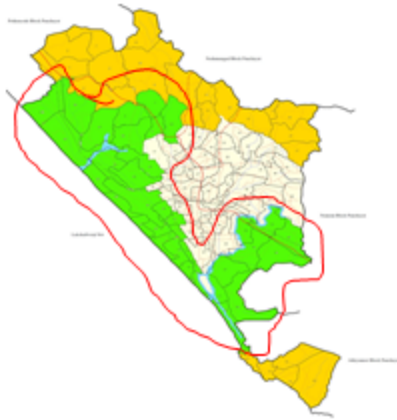
**New coverages – Block F to R**

- o Work in progress in blocks F,I,J,K,L  
Target - 31.12.2019
- o For other uncovered areas septage management is the option
